**Thermal Testing Overview**

## **Test Procedure and Results**

- 1. Date: 3/13/2023
- 2. Team Members:
  - **2.1.** John Johnston
- 3. Purpose: Evaluate Stone Thermal Scope Sample Using: Live Fire Testing
- 4. Status: Evaluation complete.

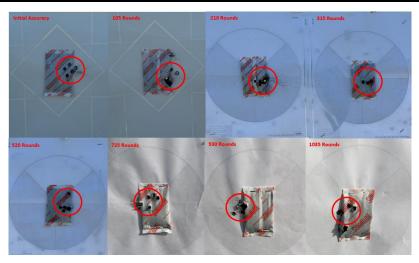
Accuracy targets for thermal sample. Targets shot in order of left to right, then top to bottom. Please note that after 315 rounds the endurance string was increased to 200 rounds to shorten testing time.
